Triumphant Times Green Country Triumphs

Monthly Newsletter for August 2020

TR6 REPAIRS By Art Graves

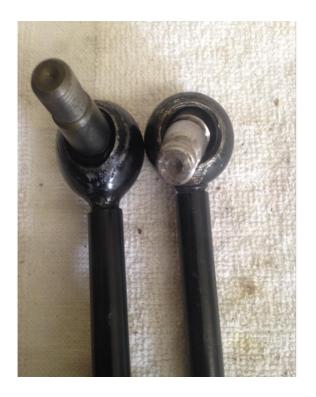
What I discovered was that the shock absorber links were completely knackered! The rubber cushion inside the ball of the link was completely gone. The picture below shows the old and new shock absorber link.

New link is on the left.

As you can imagine, replacing the shock absorber links got rid of the clunking.

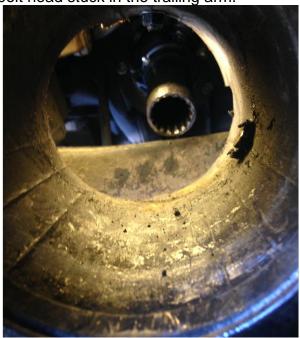
Here you can see the inside of the trailing arm. At four o'clock you can see the bolt head stuck in the trailing arm.

I puzzled over that bolt for several weeks before solving the mystery. I vaguely remember replacing the u-joints several years ago and noticing that there was not a bolt or grease fitting in the cap. What I think happened is that there was a small bolt in the cap and it worked its way loose and was flung at great speed into the trailing arm and imbedded itself there. Then each time I installed new parts it changed the geometry just enough to cause the u-joint grease fitting Since the noise began when I installed a new checkstrap, I decided to change it out again. Before doing so, I measured the thickness of the checkstrap and discovered that the installed part was .007 thousandths to hit that bolt.

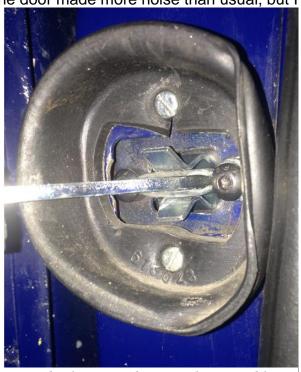
Door checkstrap and spring clip assembly

Another mystery noise was the driver side door checkstrap. I had to replace the it

The noise was caused by the movement of the checkstrap through the

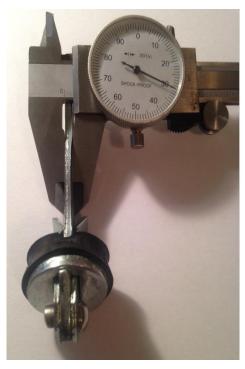
The new checkstrap measures .123 thousandths. (*Gage 11*)

The old checkstrap measures .130 thousandths. (Could be Gage 10 or 11)

Replacing the checkstrap solved the problem and, bonus, I know why. As far as I know both checkstraps came from the same supplier. Well, at least we can get parts for these old cars, right?

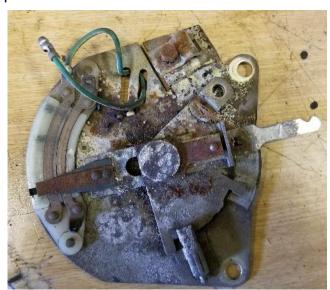
The heater switch hardware has already been removed in this view but it looks similar to the silver colored hardware on the upper right. When I got it out it looked like the photo below.

The lever protruding outward to the right is supposed to move left to right and in and out. Left to right directs the air in a

particular direction. In and out operates the fan motor from off to low to high speed. How

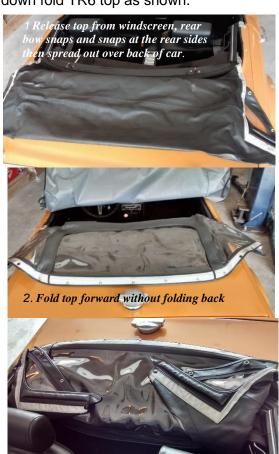
TR6 Soft Top Folding

To prevent window damage when top is down fold TR6 top as shown.

3. Fold side windows on top without folding side windows, tuck top down behind seats, add cover.
